**8 KENTUCKY STREET/  
COSMOPOLITAN HOTEL SITE**

Petaluma, California

**HISTORIC RESOURCE  
REPORT**

September 2004

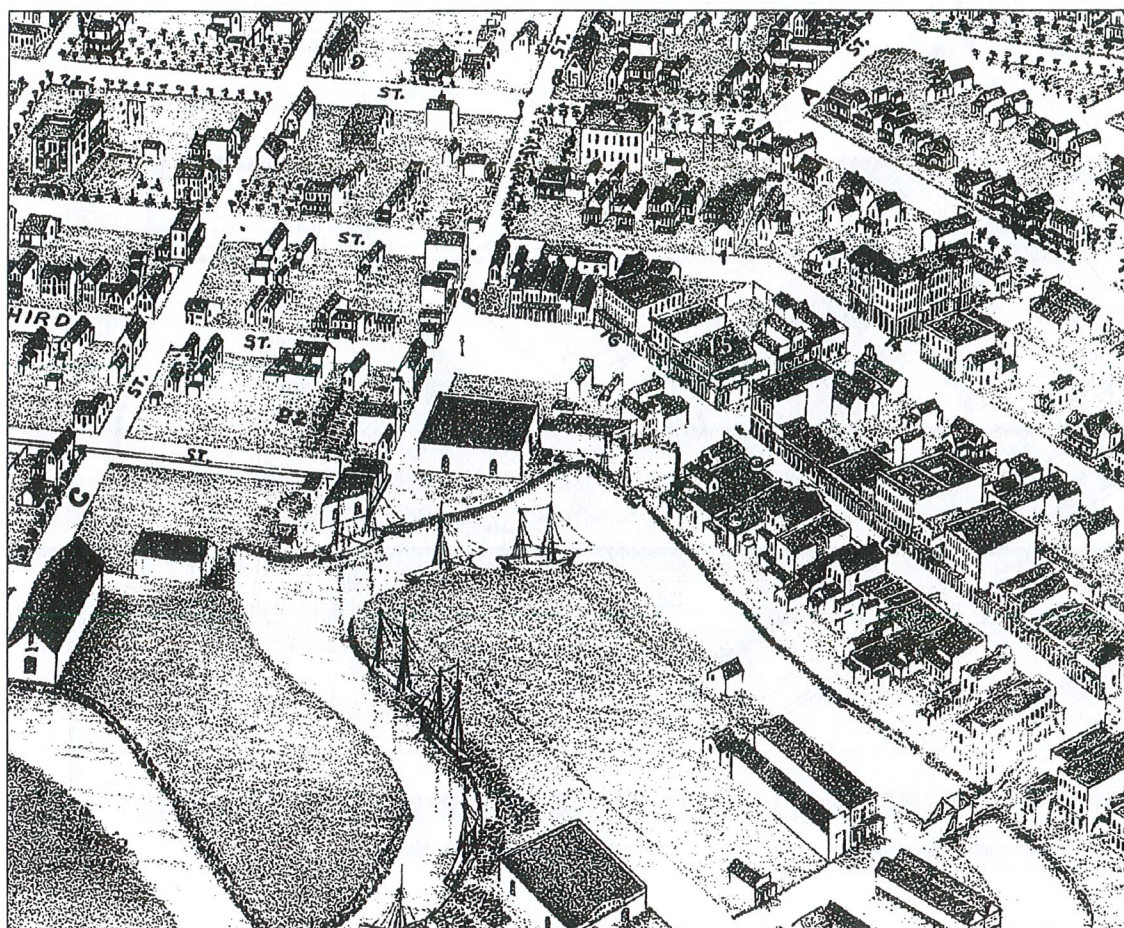
Figure 4: New York Hotel, 1871 Bird's-Eye View of Petaluma

The original building on this site was the Cosmopolitan Hotel, built in 1866. It was called the New York Hotel from 1871 to 1874 (*see Figures 4-8*). According to historian Adair Heir the Cosmopolitan Hotel was a forty-room workingman's hotel which charged from 35 to 75 cents a room in 1907.<sup>13</sup> J. P. Munro-Fraser's 1880 history of Sonoma County describes the Cosmopolitan Hotel as the first hotel on the site:

The Hotel was a three-story wood frame building with regularly spaced, single double-hung windows on the second and third floors. These displayed Italianate influences, with heavy hoods supported by corbels above the sash. A balcony with a wood rail was located between the first and second floors. The ground floor featured tall, narrow, paired double-hung windows at the storefronts. The cornice was relatively shallow, supported by paired brackets. The name of the hotel in large letters appeared between the third story windows and the cornice at the top of the parapet wall.

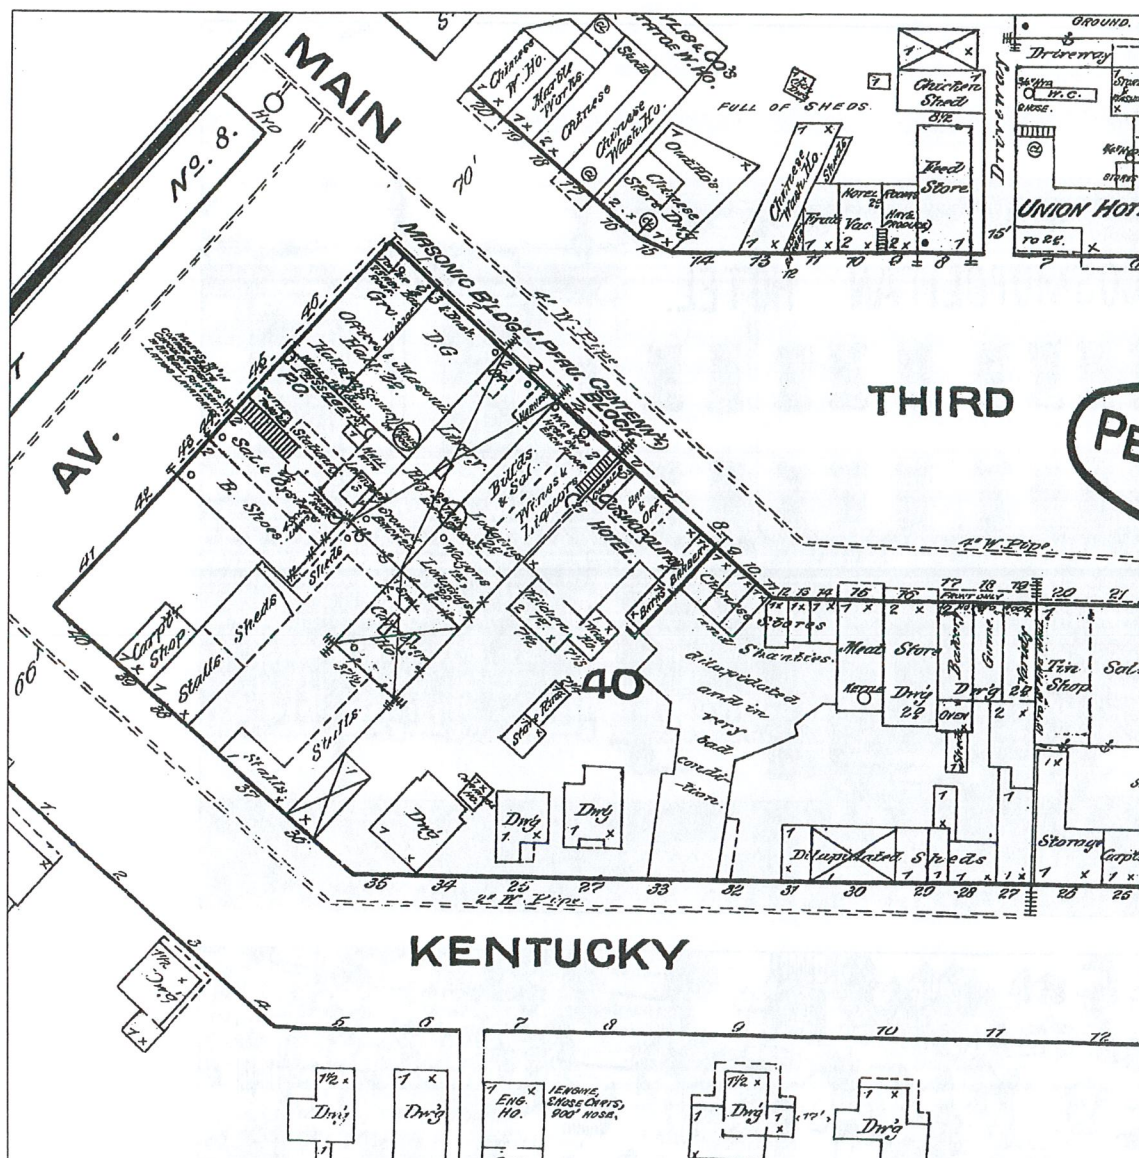
Figure 5: 1883 Sanborn map showing Cosmopolitan Hotel

Within the hotel on the ground floor was a cobbler in the northwest corner and a bar and office in the center storefront. There was a barber in the northeast corner, with a baths to the rear of that. Storerooms were located to the rear of the lot along the middle of the east property line. The hotel was addressed as 0, 2 and 8 Main Street in the mid-1880s. At the end of the 1880s it was addressed as 6 and 7 Main Street.

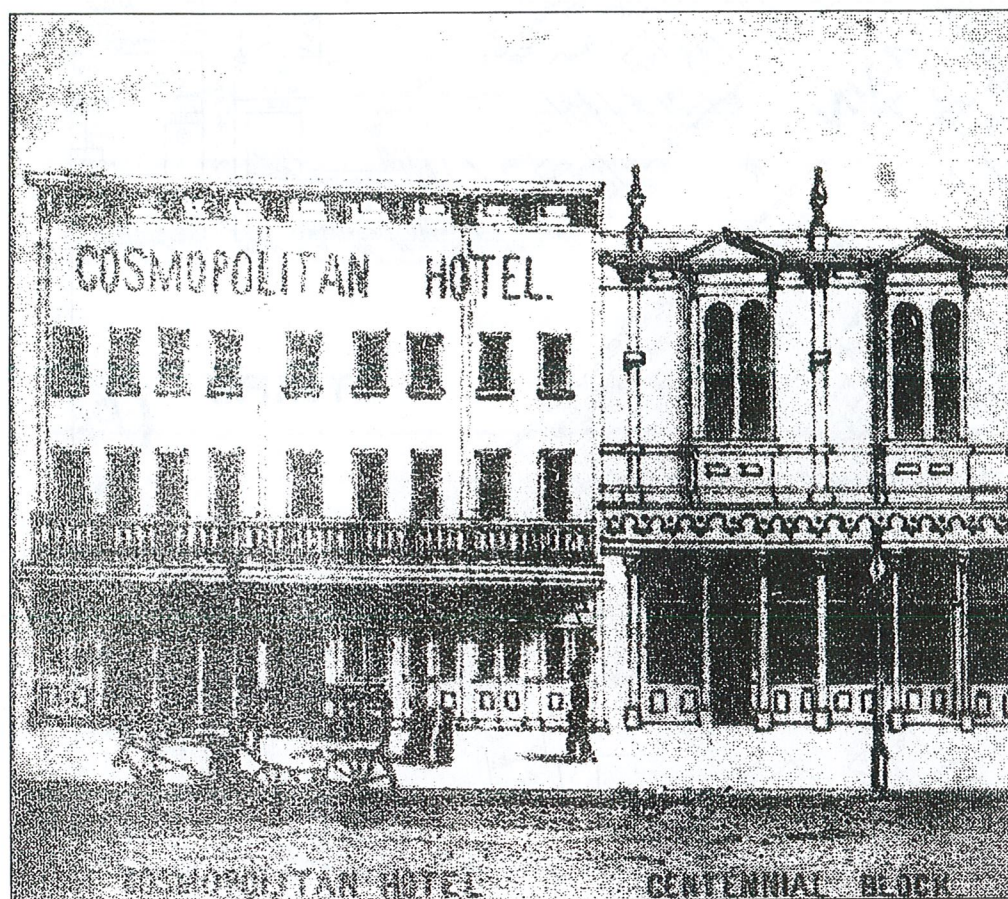
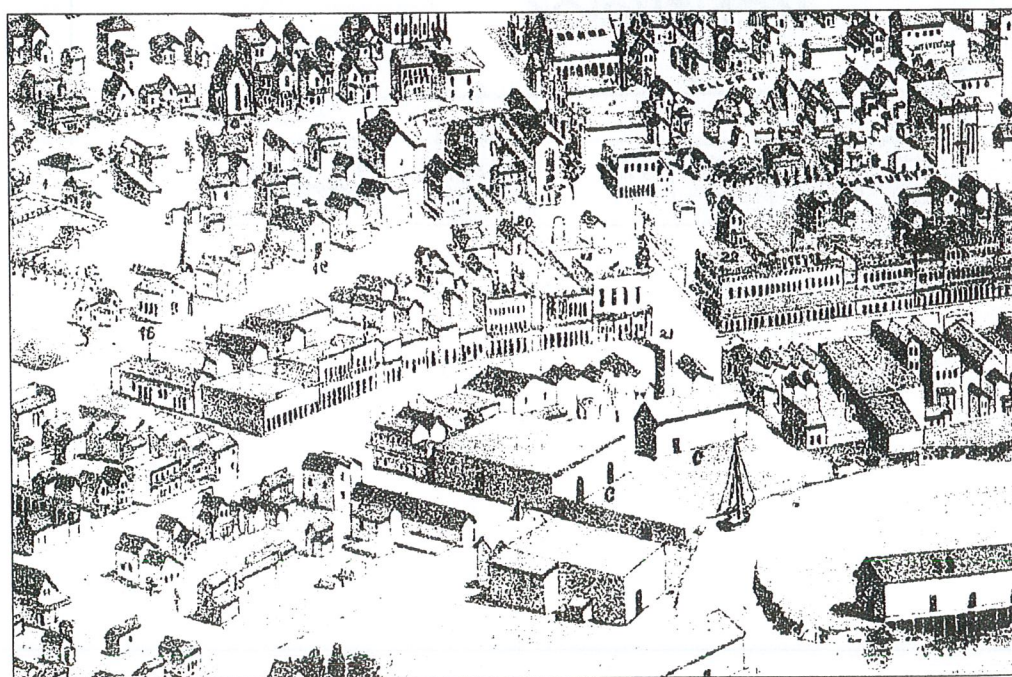
Figure 6: Elevation and bird's-eye view of Cosmopolitan Hotel from 1884

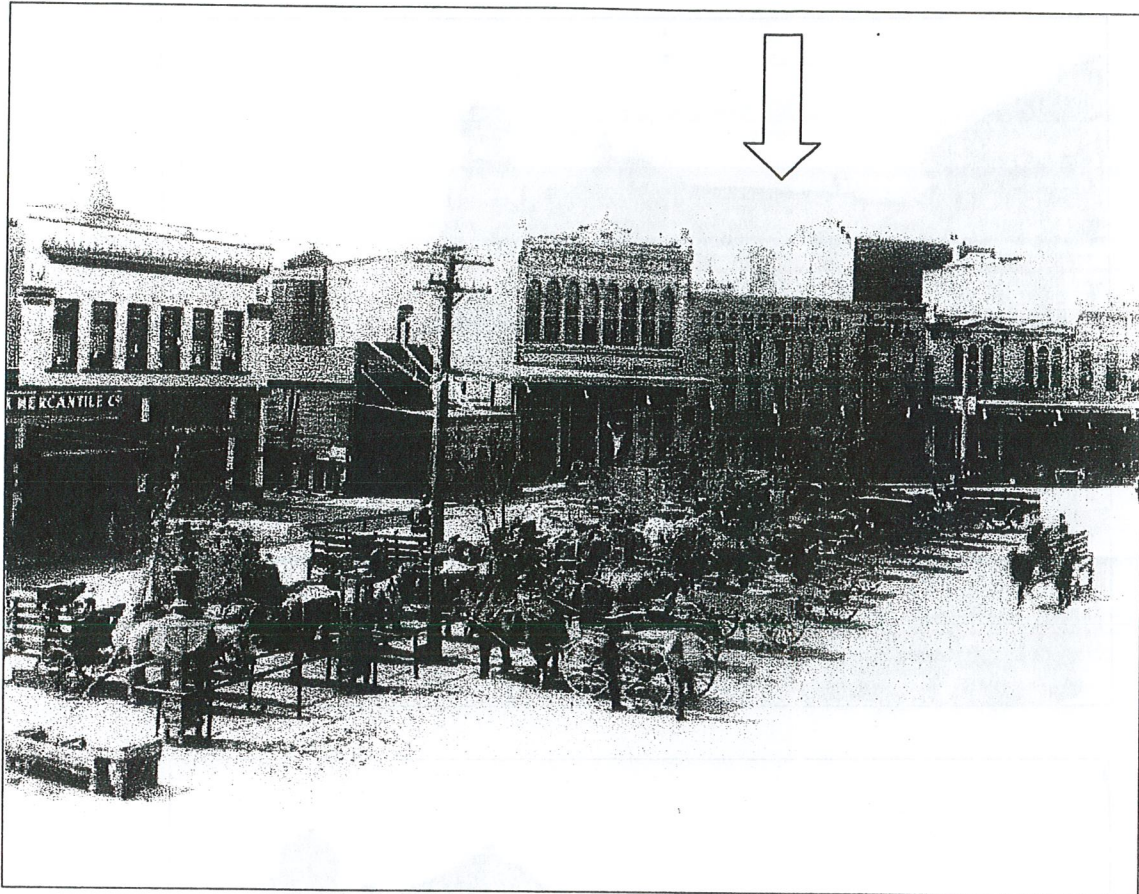
**Figure 7: Historic view of Cosmopolitan Hotel**

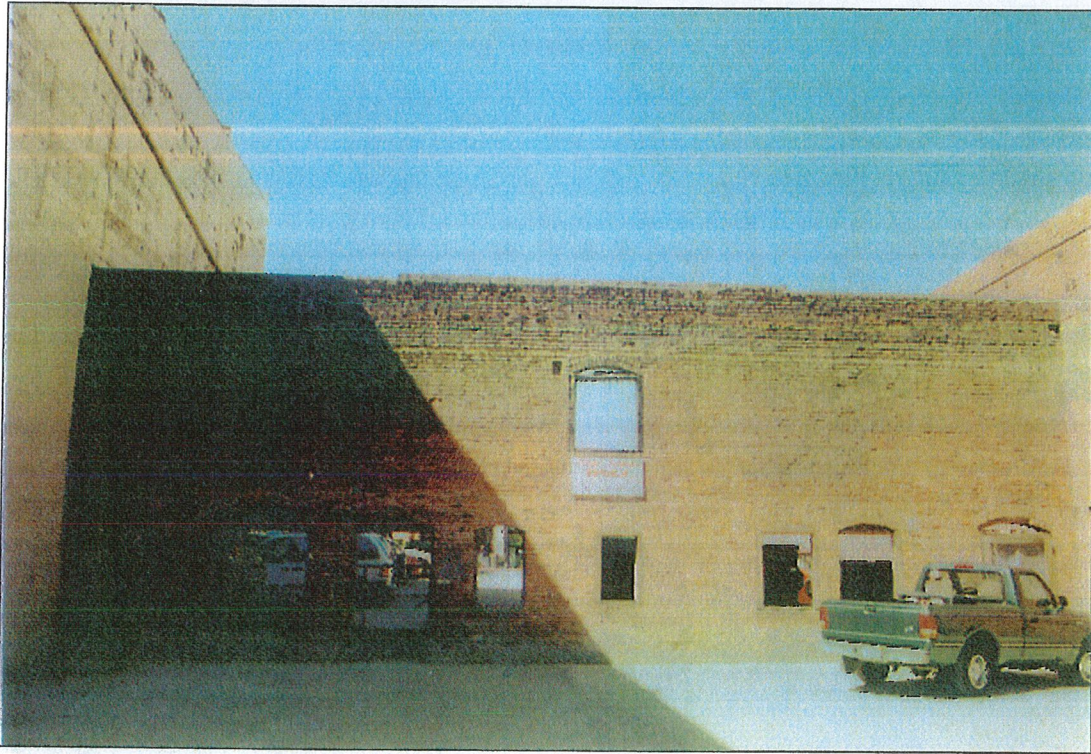
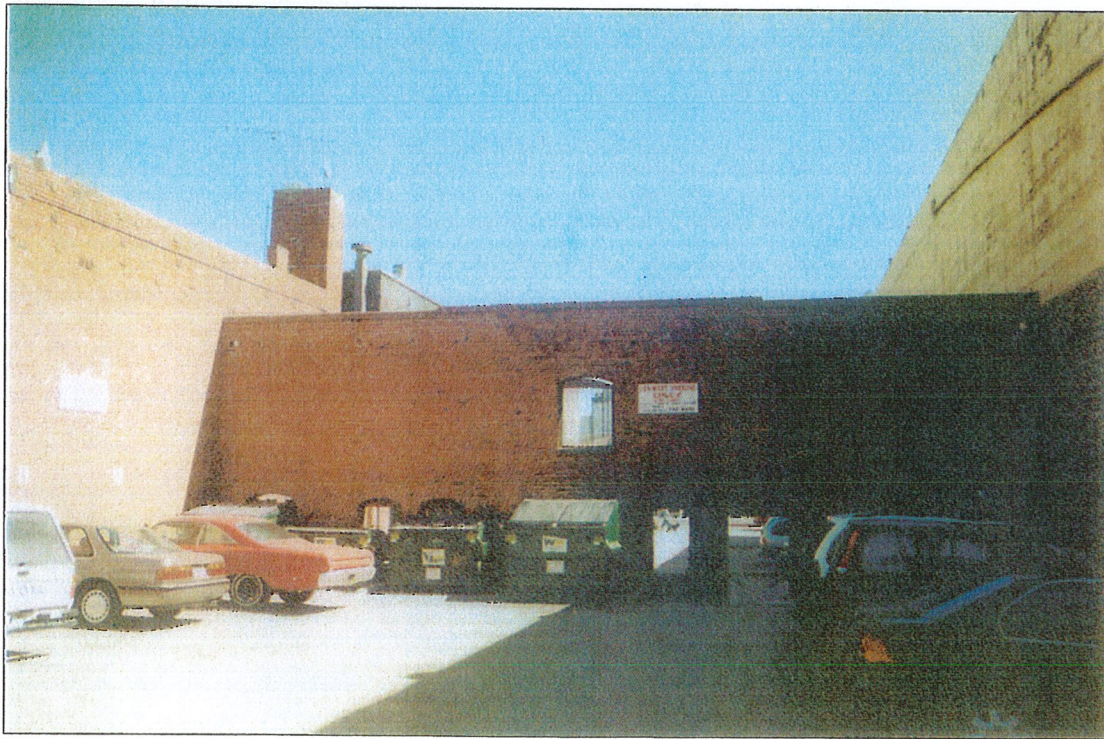
View from north

View from south

Figure 9: Views of remaining rear wall of Gervasoni Building

The wall remaining at 8 Kentucky Street is essentially the back wall of a structure that was built some time between 1910 and 1919. It is approximately 24 feet high, 12 inches deep at the base, and extends from the McNear Building on the east to the LanMart Building on the west. It is located at approximately the two-thirds point in the lot; in other words, two thirds of the depth of the lot is on the Petaluma Blvd. North side and one third is on the Kentucky Street side (*see Figure 2*).

The wall is a load-bearing brick masonry wall. There is a narrow brick coping at the top of the wall which steps slightly in the center. There are two door openings and seven window openings, all of which feature a shallow brick arch. The window sash and door jambs are wood. Viewed from the Kentucky Street side, one door is located almost adjacent to the LanMart Building wall, and there is a paired set of what were double-hung windows to its right. Near the center of the wall is another double-hung window of medium width. Above this, at what appears to have been the mezzanine level, is a wider arched opening with narrow vertical metal bars. This appears to have been a fixed window. Flanking the door on the right hand side of the wall are two windows, a narrow double-hung window opening to the left, and a wider window to the right. To the right of

The party wall of the southwest corner of the building is still extent. It is only one brick deep, which indicates that it was not a structural wall, but was using the LanMart Building wall or another means for structural support. There is no vestige of a wall on the McNear Building side. It is not clear whether this same condition occurred on this side of the building. In the party wall are voids where floor joists would have been located. The joists are at the approximate level of the arch of the door opening adjacent to it. This and the overall floor-to-ceiling height of the store room at the lower and mezzanine level suggests that ceiling heights were relatively low.

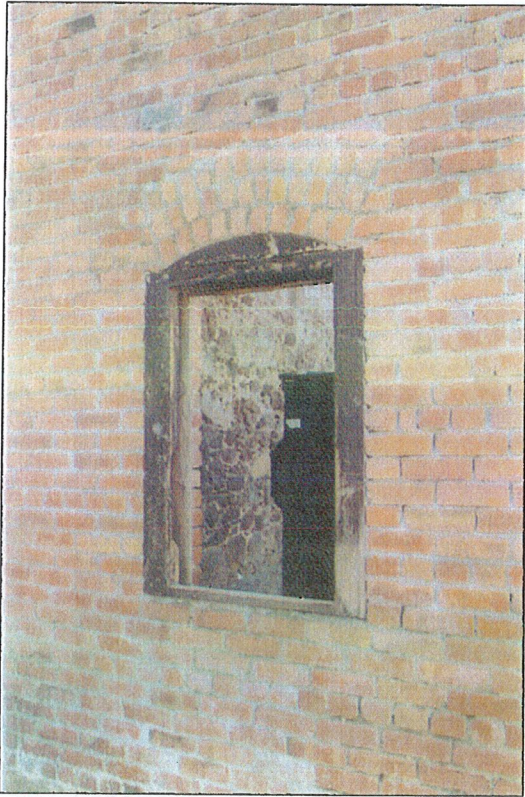
Window detail

Figure 10: Details of remaining wall from Gervasoni Building

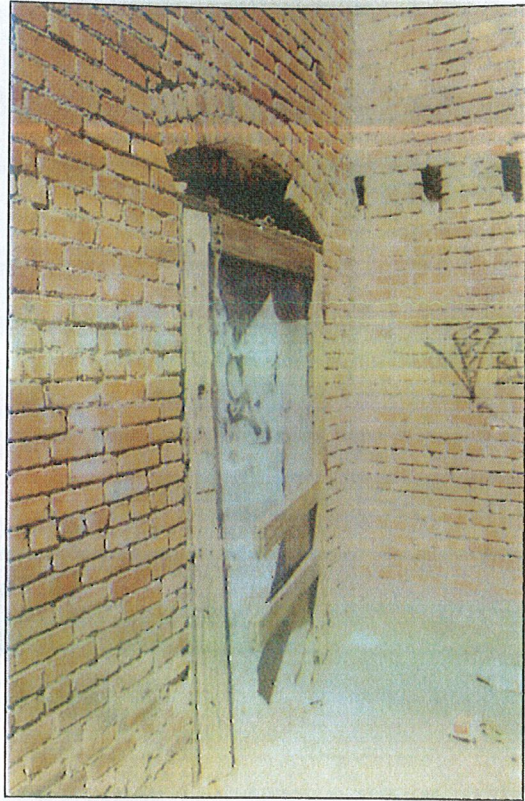
Door detail, west side
